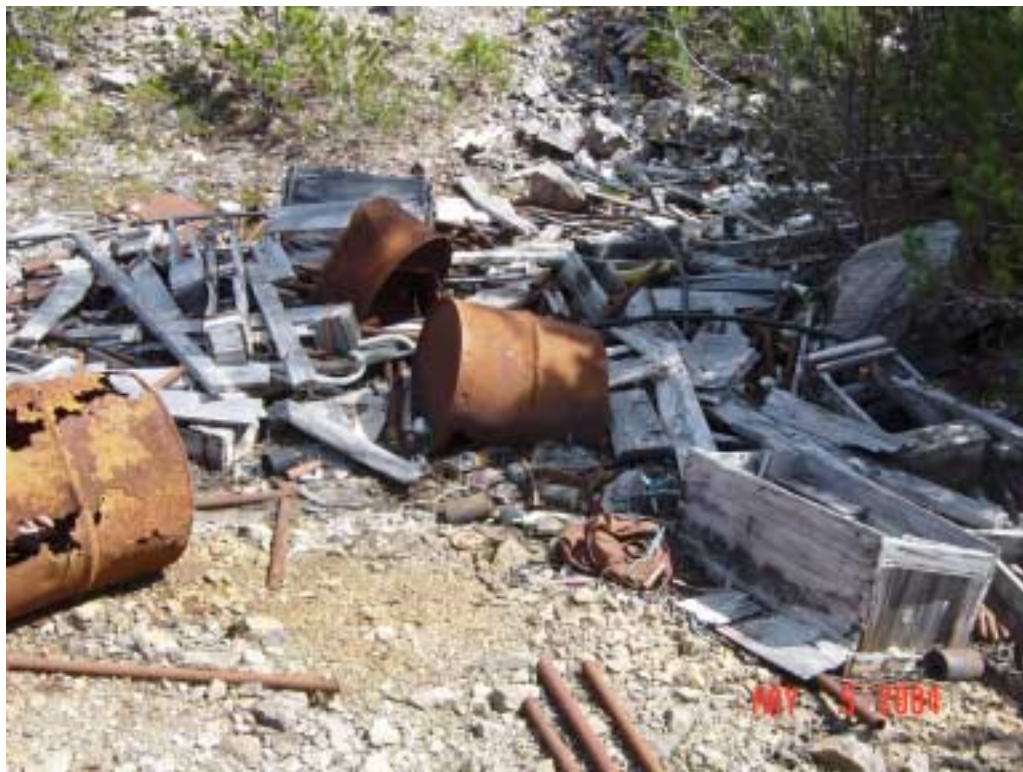
Photograph 5. Remains of an apparent shop or storage building at the 900-foot level.

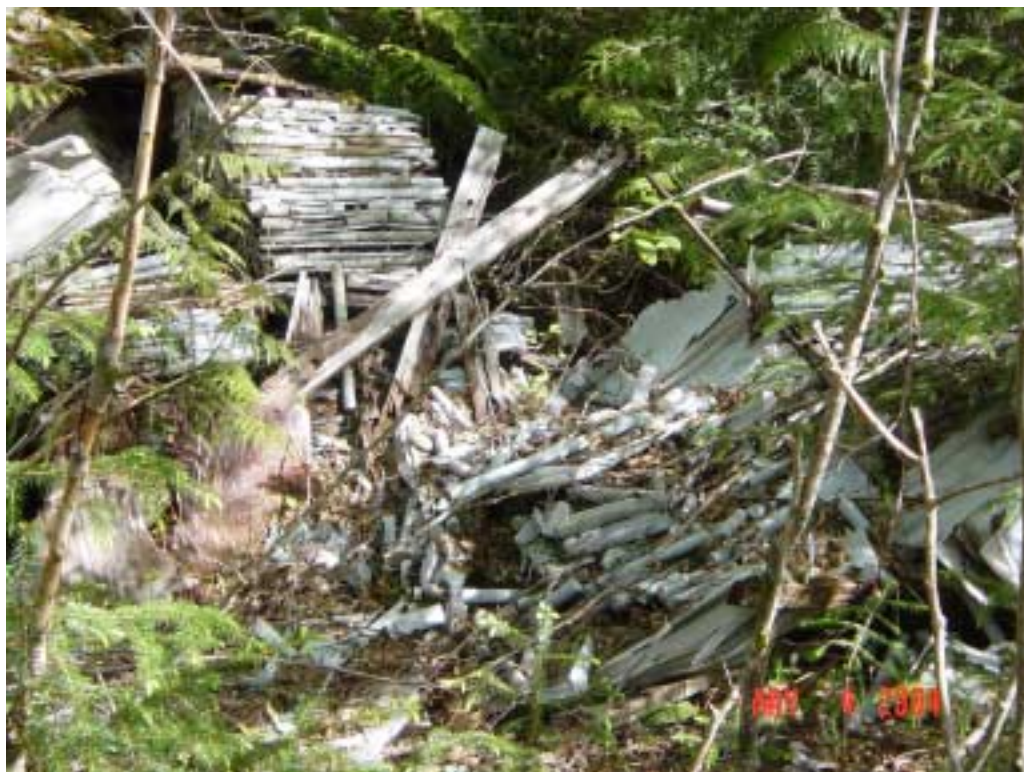
Photograph 8. Collapsed drill core stacks at the 300-foot level.

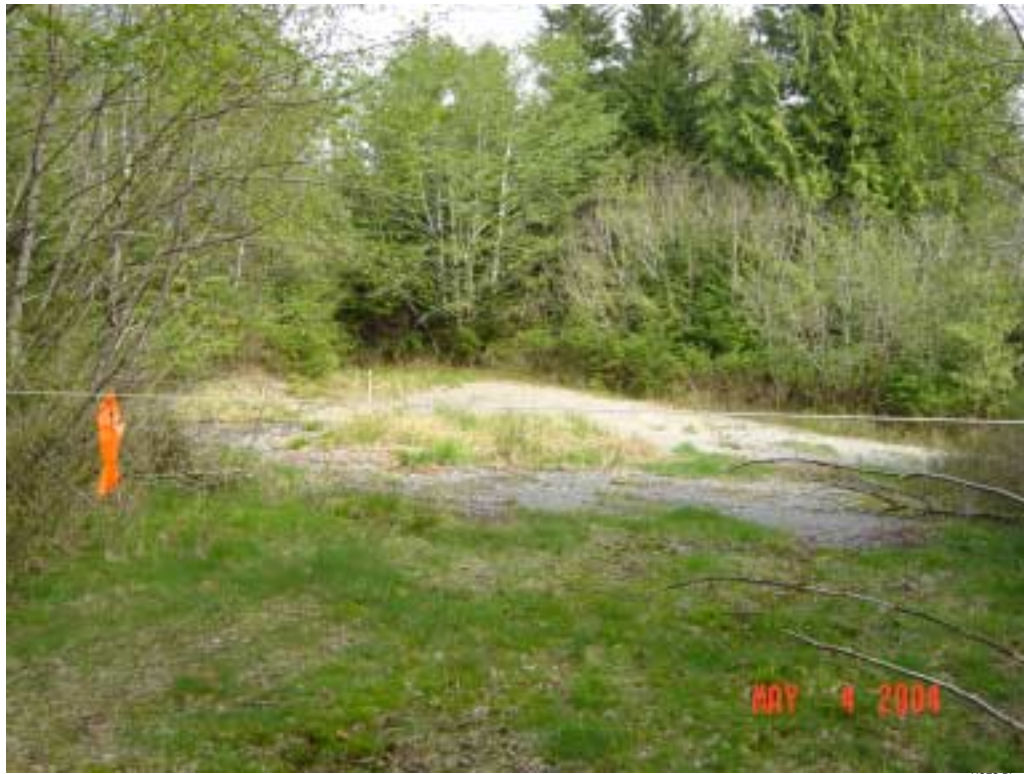
Photograph 9. Looking east across center of OSA waste rock pile.

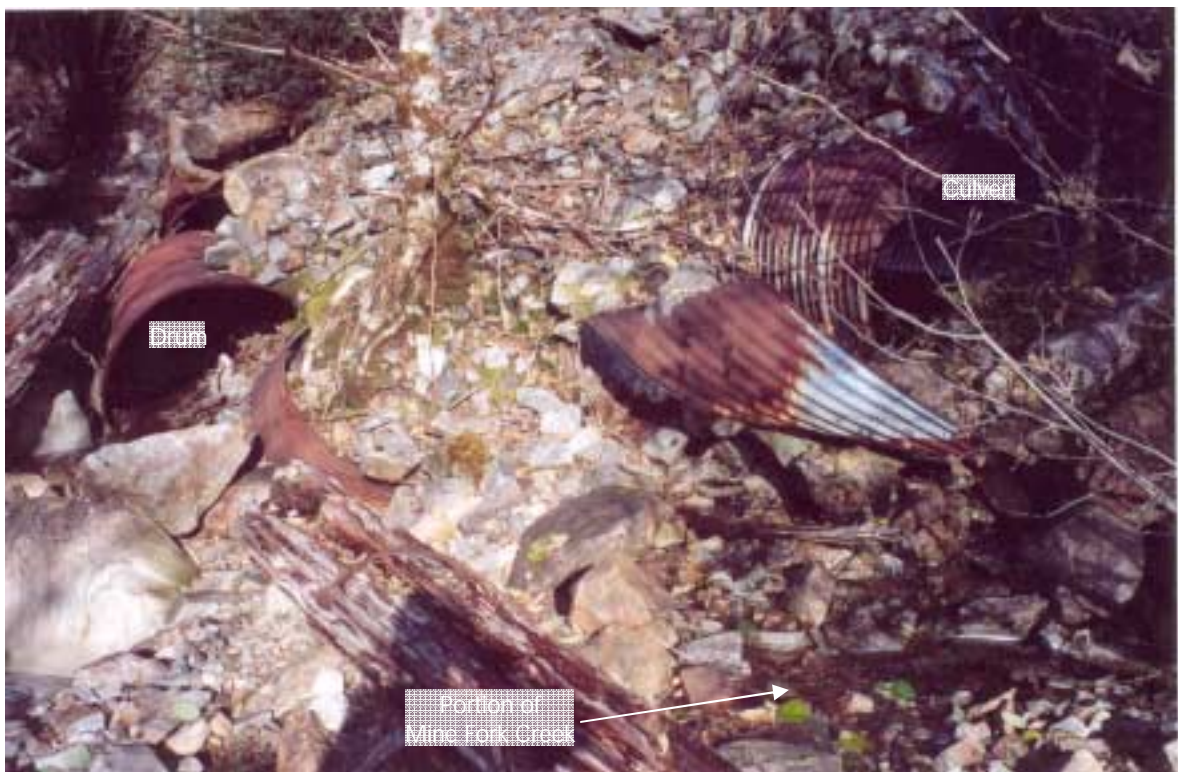
Photograph 16. Looking north at the toe of the 300-foot level dump showing one of two culverts carrying part of the Mine Fork Creek flow under the dump. PPE-3 is upstream of this location where waste rock is first present in the creek.

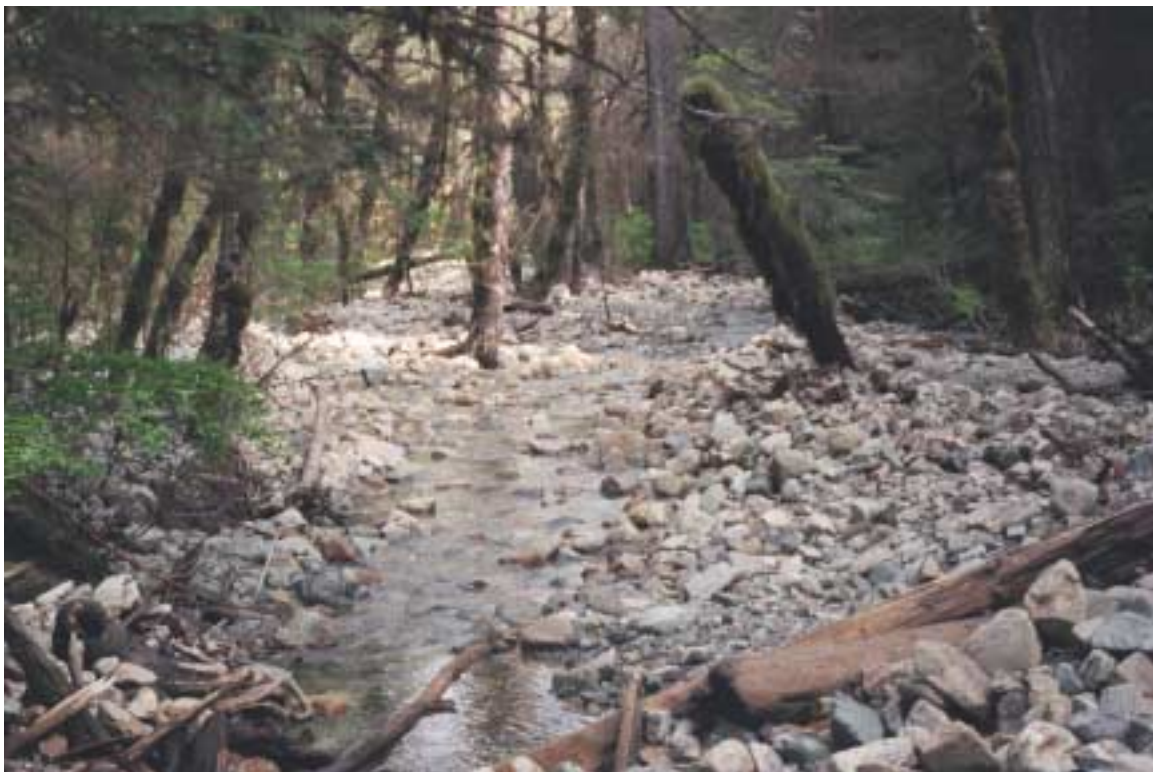
Photograph 17. Kendrick Creek upstream of SSED-06 sample location. Note boulder and cobble stream bed and wide flood channel.

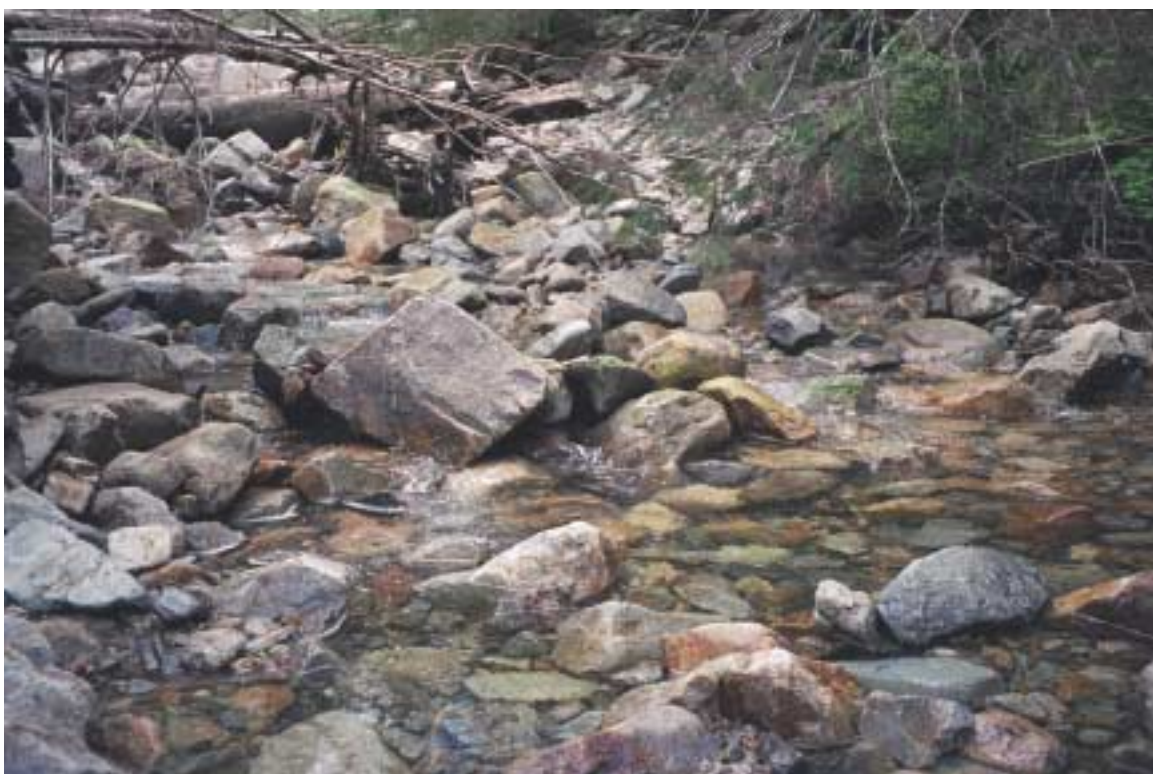
Photograph 18. Kendrick Creek near SW-08 sample location. Note boulder stream bed with paucity of sand-sized and finer sediments.

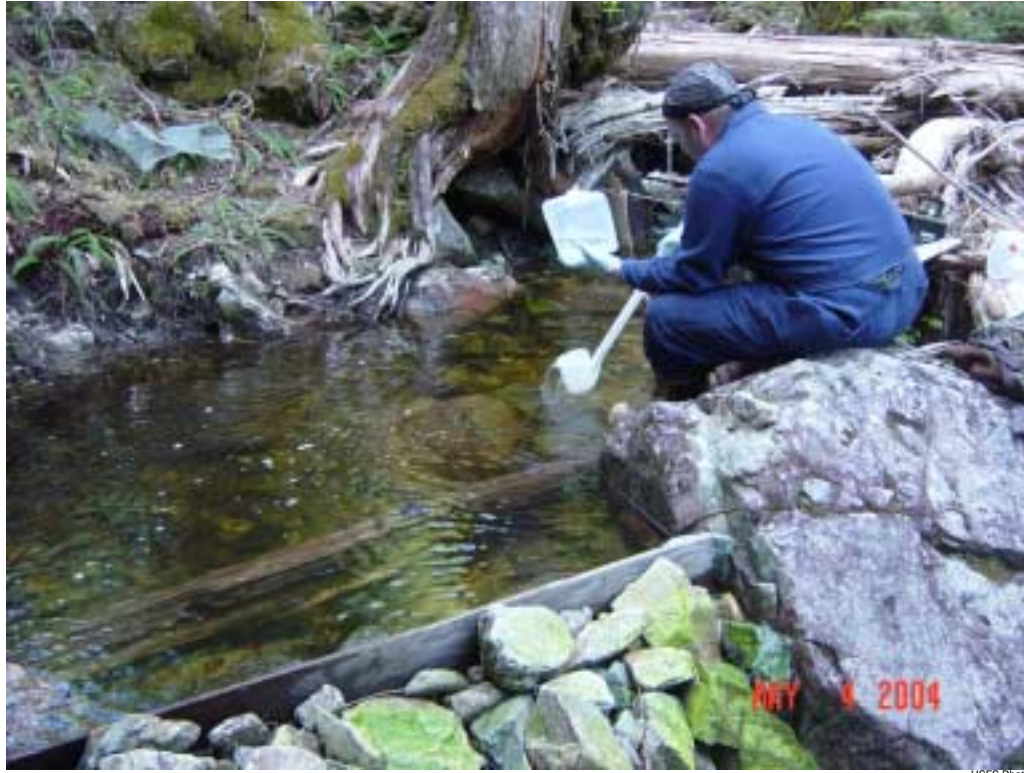
Photograph 30. Collecting sample SW-04 from Cabin Creek. The pool shown in the photo is the drinking water intake for the Dotson cabin.

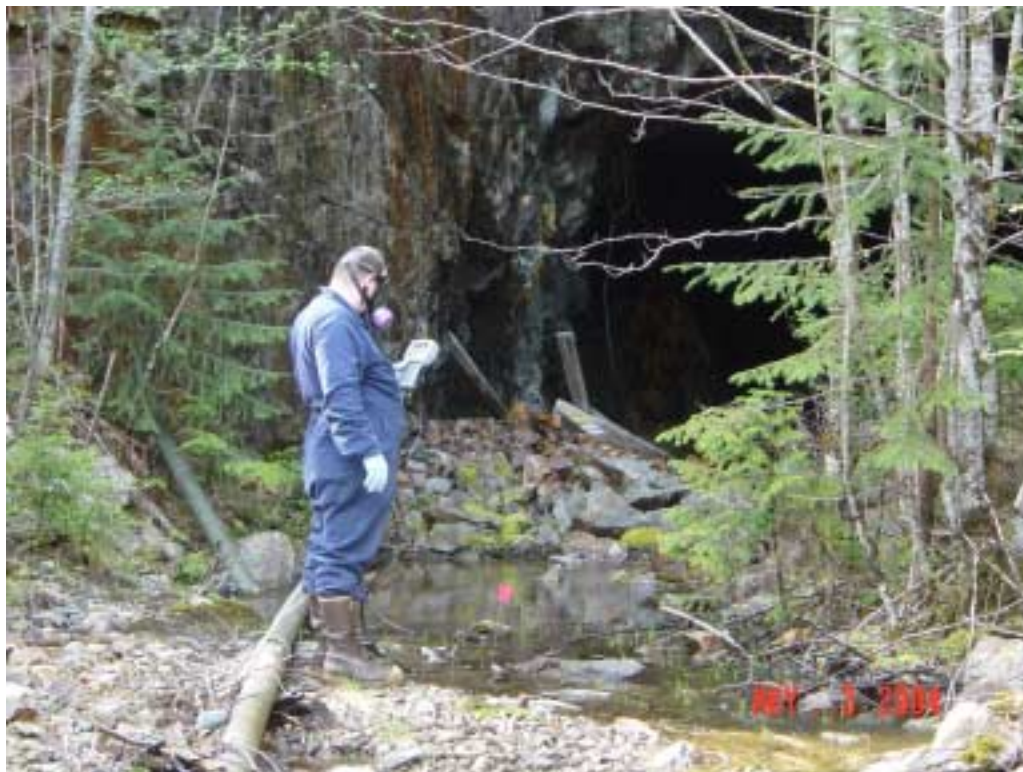
Photograph 32. Collecting sample SW-07 outside 300-foot level adit portal.

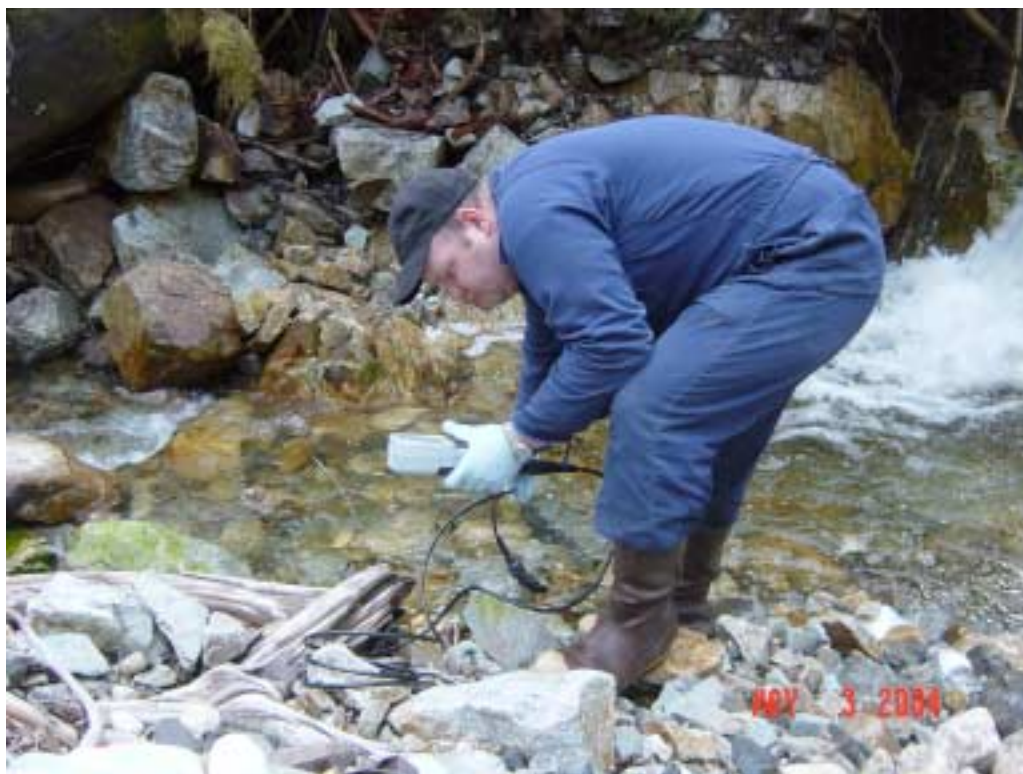
Photograph 34. Collecting sample SW-08 below 300-foot level dump.

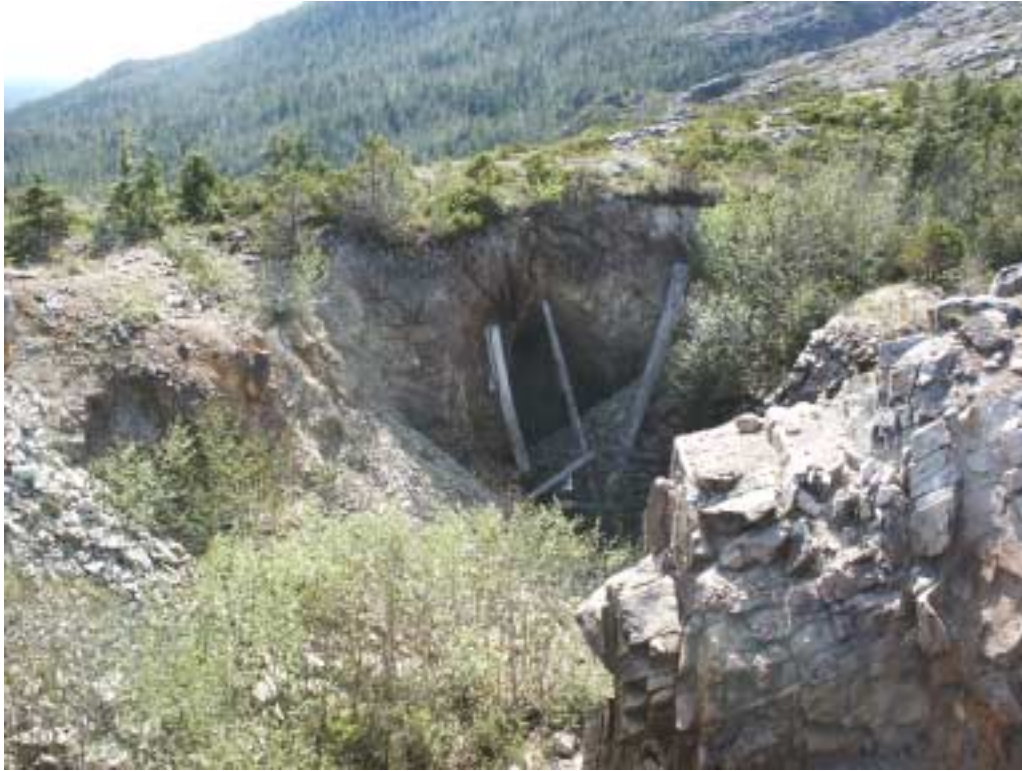
Photograph 44. Looking south at the 900-foot level open pit and stope opening. Radon detector R900-02 is deployed at the stope opening on a line dropped from the pit edge.

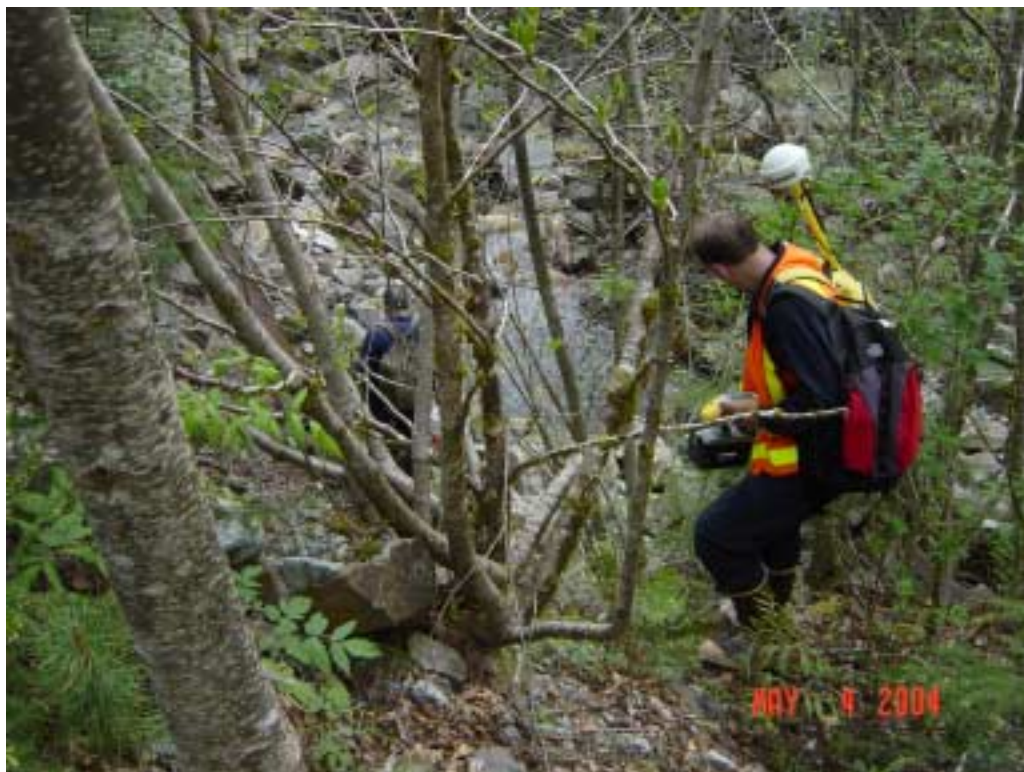
Photograph 50. GPS survey at the 300-foot level. GPS reception and accuracy in this area was degraded by the dense vegetation visible in the photo.

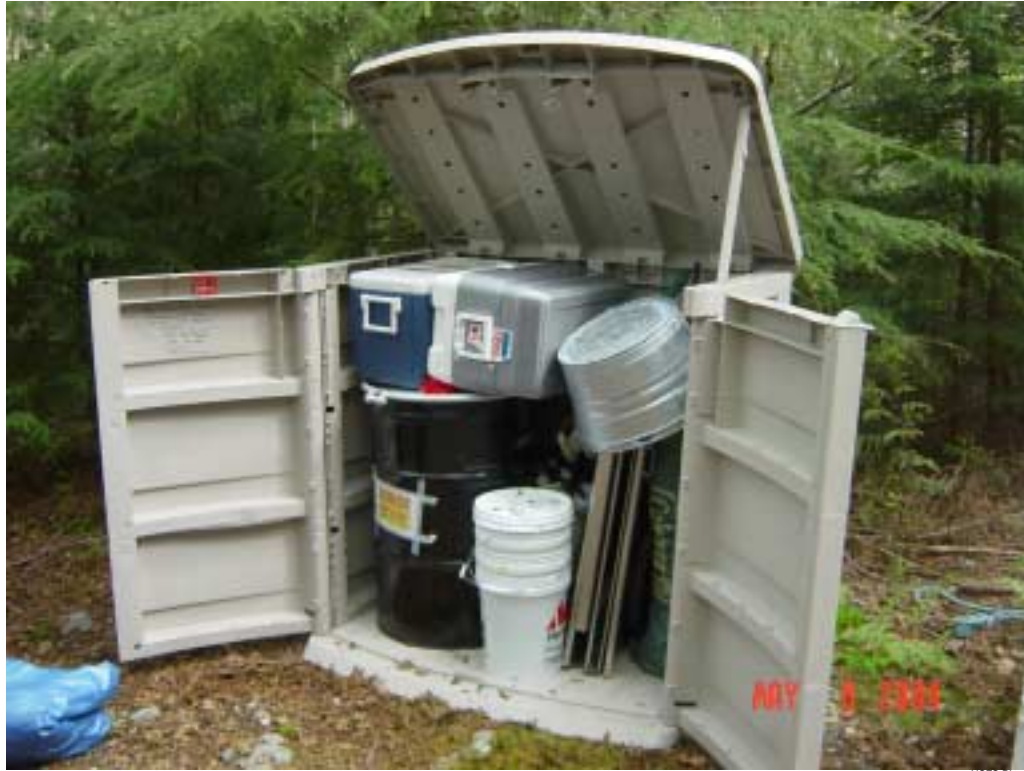
Photograph 51. Investigation derived wastes and miscellaneous field equipment stored on-site in a rain-proof shed at the completion of the 2004 SI.

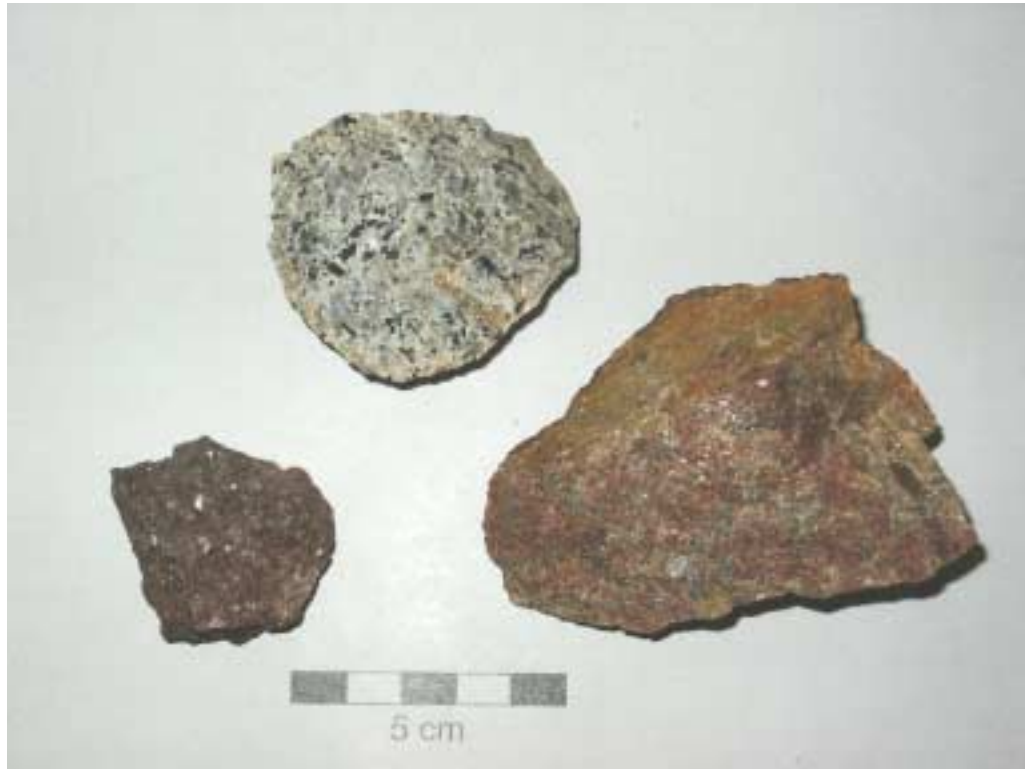
Photograph 53. Two specimens of uranium and thorium mineralized hematitic granite porphyry (left and right) compared to unaltered and unmineralized aegirine granite porphyry.

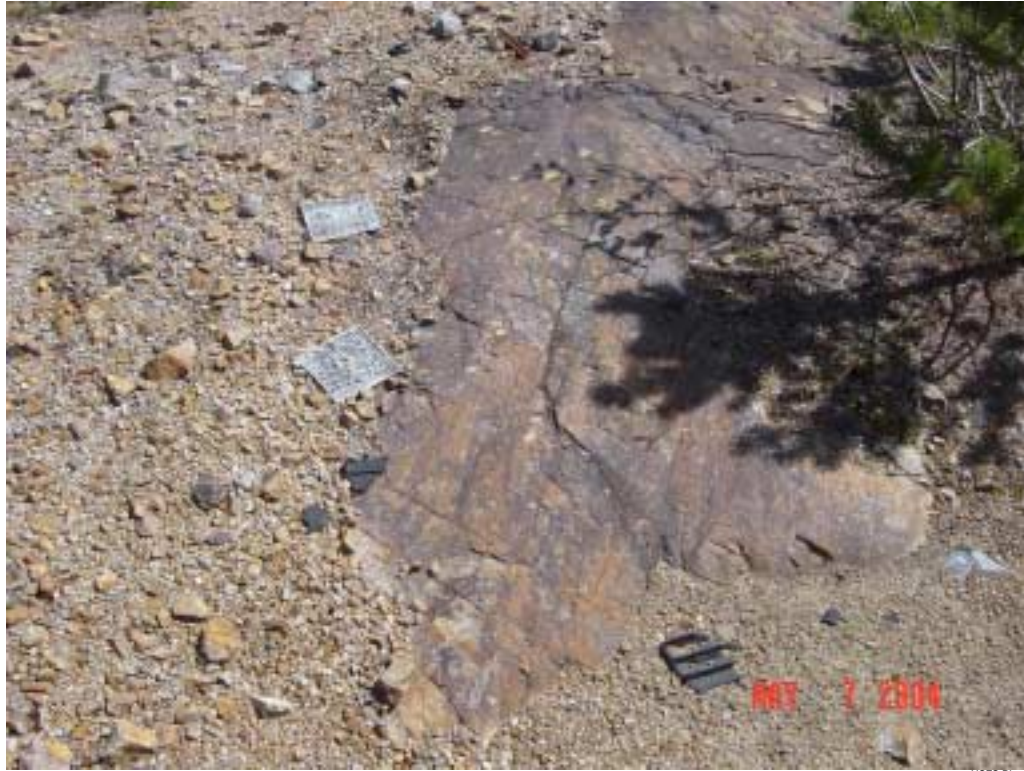
Photograph 55. Lead-acid battery plate material on soil at the 900-foot level.

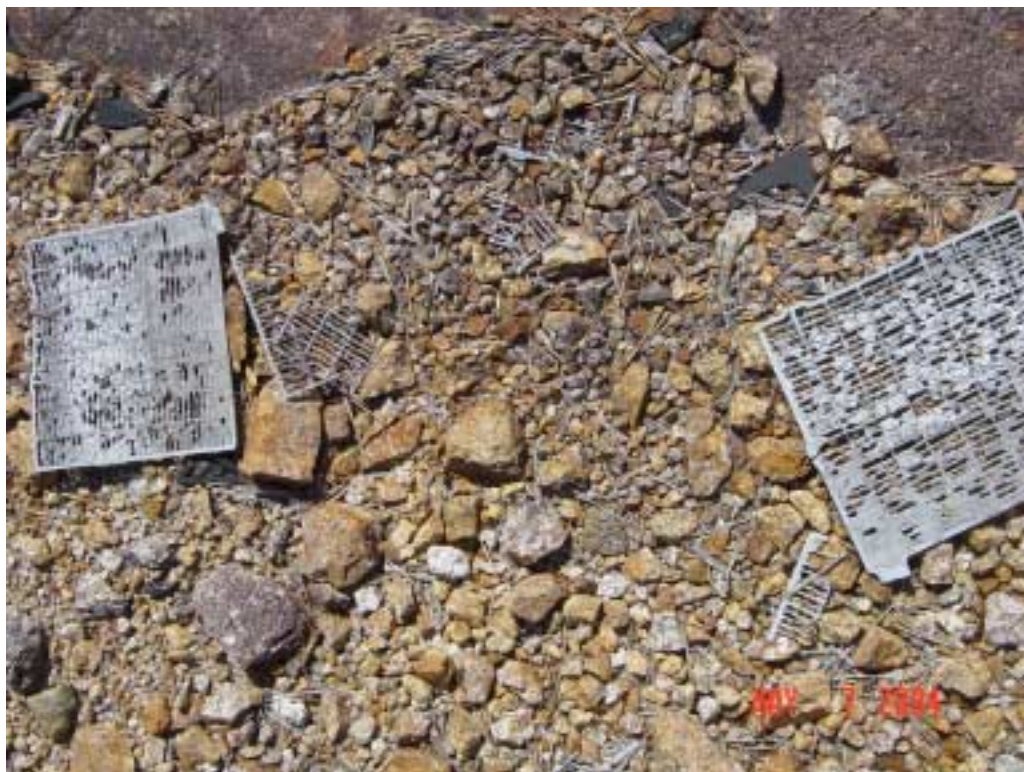
Photograph 56. Close-up of battery plate material.

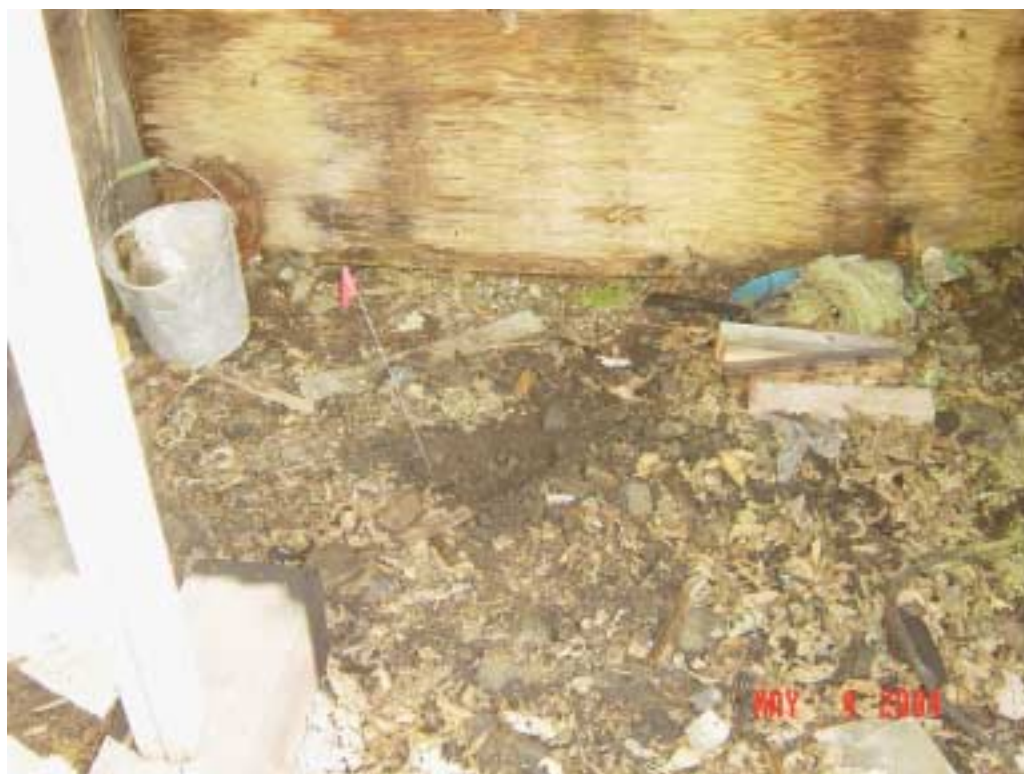
Photograph 58. Soil sample location GEN-02 in generator building.

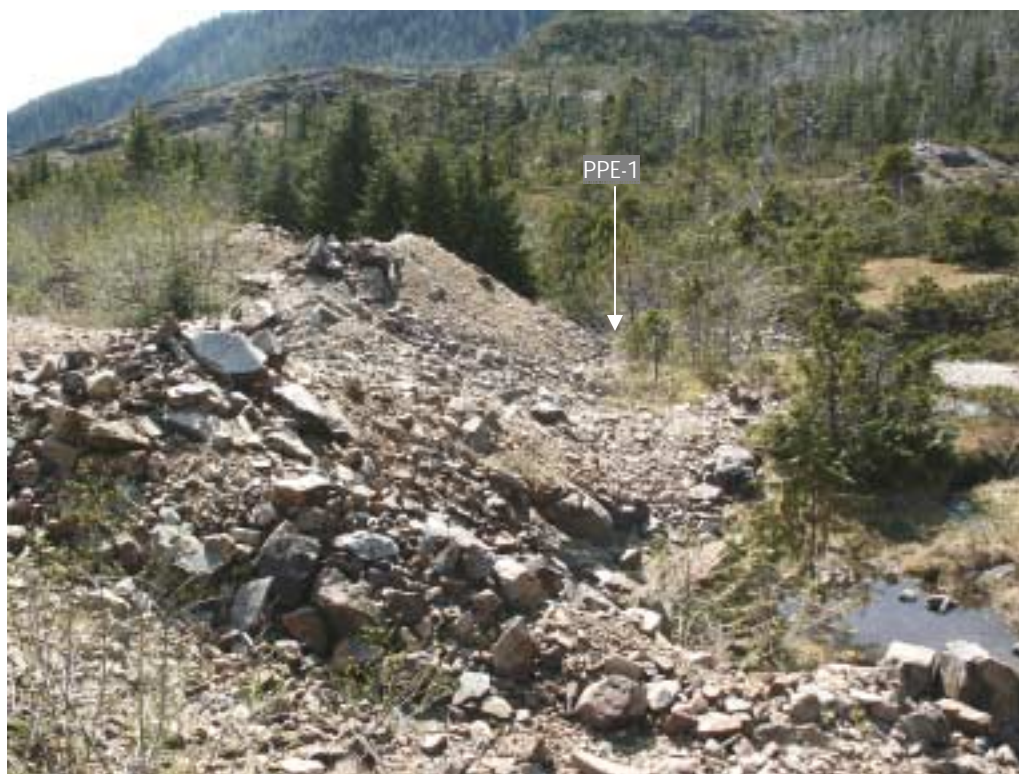
Photograph 59. Looking south along the west side of the 900-foot level north dump. PPE-1 is at the dump toe where dump material is in Mine Fork Creek.

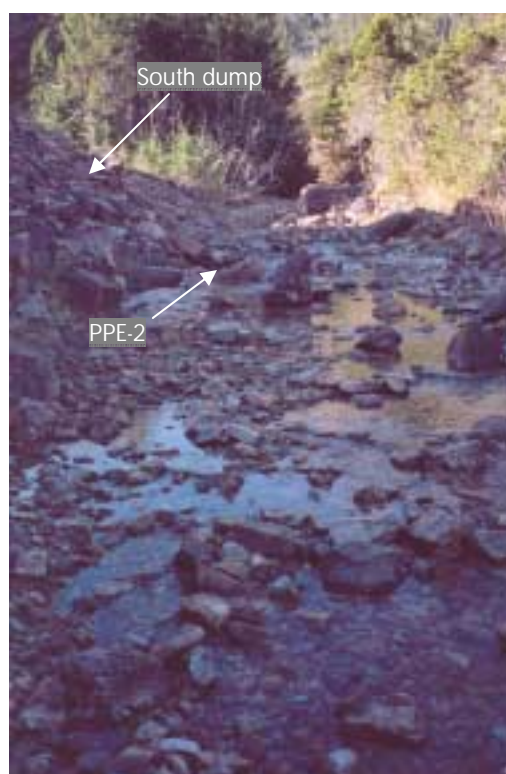
Photograph 60. Mine Fork Creek looking west with the toe of the 900-foot level south dump visible in the creek. PPE-2 is located at the dump toe.

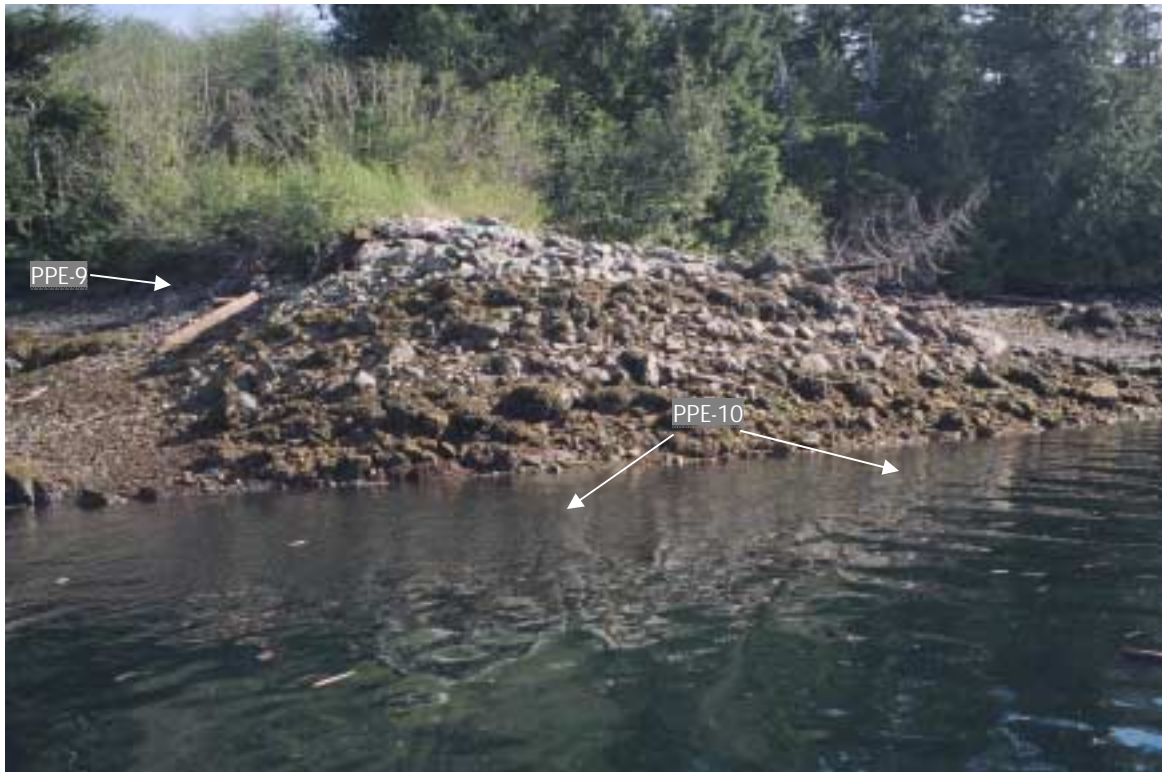
Photograph 61. The former loading dock bulkhead exposed at low tide. Marine sediment samples MSED-07 and MSED-08 were collected at the base of the bulkhead. PPE-9 is at the edge of the OSA waste rock pile and PPE-10 is in the submerged area at the bulkhead toe.
